**Flood Control Project Maintenance
Levee Inspections**
LMA District Cover Sheet
Spring 2019 Levee Inspection Results

Madera County FCWCA

Spring 2019 Levee Inspection Results

Waterway			Bank	Unit Miles
Unit No. 01 Ash Slough			Right	2.37
	Spring (March - May)	Summer (June - August)	(September - November) Fall	Winter (December - February)
Unit Maintenance Rating (Fall Only)				
Date of Inspection	5/9/2019 - 5/9/2019			
DWR Inspector	Corey Fujitani			
Accompanied By	Dario Dominguez Madera County

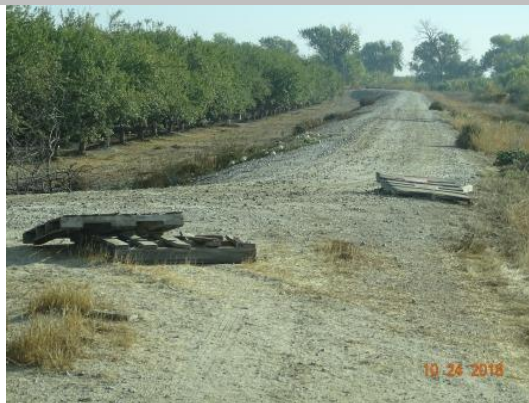
Photo 1 of 1 : SP_2019_NA0011_142_15_20190307_00007.jpg

Pallets left on levee crown. (Fall 2018)

LM Start	0.03	Rating **	U	Issue No.	18
LM End	0.06	Issue Type +	En	Location *	LS
Category	Earthen Levee			GPS Latitude/Longitude	
				Start	End
Item	Encroachments			37.046566 °	37.046715 °
				-120.427512 °	-120.426964 °
DWR ID	DWR_NA0011_01_s_2014_18				
Comment Code					
DT : Ditch					
Inspector Comment					
There seem to be lots of activity going on at this location. This ditch will cause more damage to the levee slope and toe.

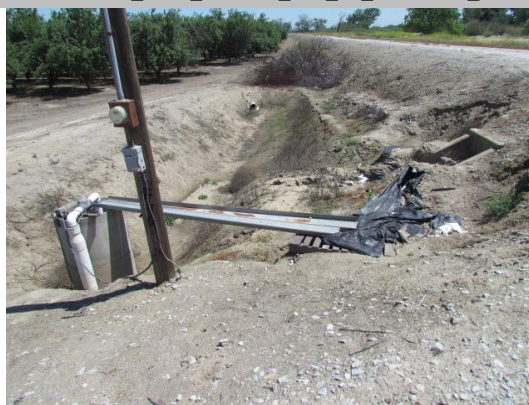
Photo 1 of 1 : SP_2019_NA0011_142_18_20190307_00009.jpg

Ash Slough looking upstream from the landside slope levee mile 0.03.

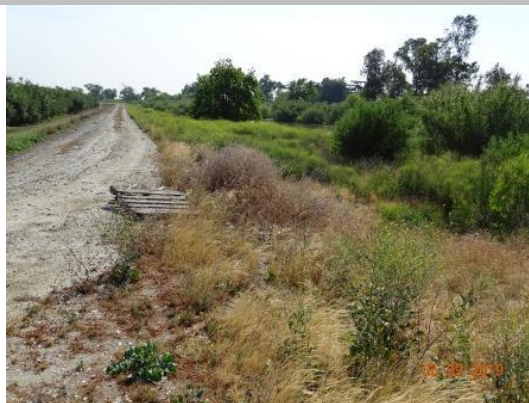
Photo 1 of 1 : SP_2019_NA0011_142_22_20190513_00032.jpg

LM Start	0.03	Rating **	U	Issue No.	22
LM End	1.12	Issue Type +	Ma	Location *	WS
Category	Earthen Levee			GPS Latitude/Longitude	
				Start	End
Item	Vegetation			37.046573 °	37.056183 °
				-120.427510 °	-120.413348 °
DWR ID	DWR_NA0011_01_s_2019_22				
Comment Code					
V1 : Control annual grass and weeds on the levee slopes and easements.					
Inspector Comment

View of vegetation on waterside slope looking upstream. (Spring 2019)

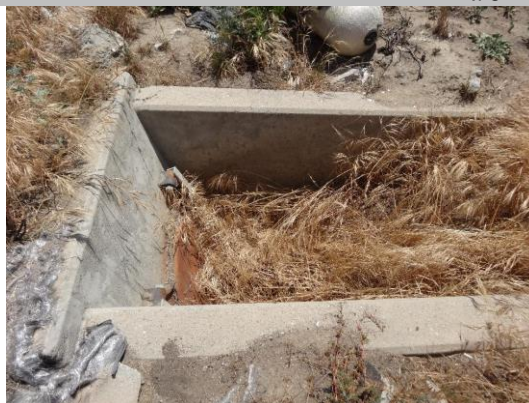
Photo 2 of 3 : UCIP_SP_2019_53153_69673.jpg

FS_ID:53153
DS_ID:21513
EP_NO: N/A
Repair Type: Urgent
Crossing Status: Found
UCIP Comments: 10/31/2018 Erosion present on both the right and the left side of the concrete headwall located on the LS. Pipe inlet is about 50 percent filled with soil. WS outlet is at a low point, water will pond against the levee until it reaches channel elevation. This crossing does not properly drain to the channel. Levee is composed of highly erodible material. Recommend clearing soil from pipe and completing internal pipe inspection to determine pipe integrity through levee. (O. Magana - DWR UCIP)
07/14/2016 No inspection completed--need to inspect October 2016.
(DWR UCIP - omagana)05/06/2014 Landward slope has been excavated and a berm built in front of landward headwall. Sediment visible inside pipe from landward side. Dense vegetation limits the inspector's visibility to identify signs of pipe failure (leaks) along the waterward slope. Recommend removing vegetation along pipe alignment and waterward headwall to conduct proper inspection of structure. (DWR UCIP - omagana)

Flap gate located on WS blocked by dense vegetation.

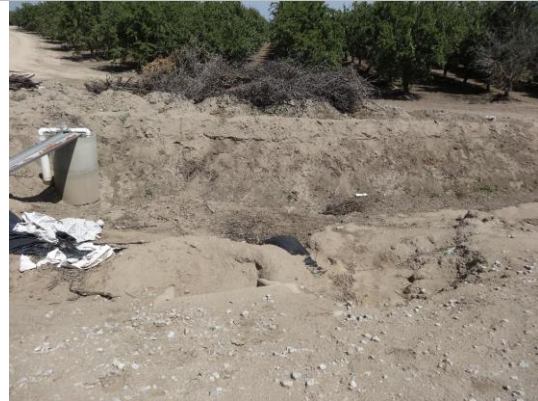
Photo 3 of 3 : UCIP_SP_2019_53153_69675.jpg

Comment Code						
Inspector Comment						
FS_ID:53153 DS_ID:21513 EP_NO: N/A Repair Type: Urgent Crossing Status: Found UCIP Comments: 10/31/2018 Erosion present on both the right and the left side of the concrete headwall located on the LS. Pipe inlet is about 50 percent filled with soil. WS outlet is at a low point, water will pond against the levee until it reaches channel elevation. This crossing does not properly drain to the channel. Levee is composed of highly erodible material. Recommend clearing soil from pipe and completing internal pipe inspection to determine pipe integrity through levee. (O. Magana - DWR UCIP) 07/14/2016 No inspection completed--need to inspect October 2016. (DWR UCIP - omagana)05/06/2014 Landward slope has been excavated and a berm built in front of landward headwall. Sediment visible inside pipe from landward side. Dense vegetation limits the inspector's visibility to identify signs of pipe failure (leaks) along the waterward slope. Recommend removing vegetation along pipe alignment and waterward headwall to conduct proper inspection of structure. (DWR UCIP - omagana) FIELD_STRUCT_DESC: 30-inch corrugated metal gravity drainage pipe through the levee, 9.5 feet below the crown. Headwall and wing wall on each end. Flap gate on the waterside (WS) end. [Additional Reference(s): DWR Levee Log, 2005]. FS Date: 10/31/2018 11:25:00 AM

View of LS--levee slope has been modified.

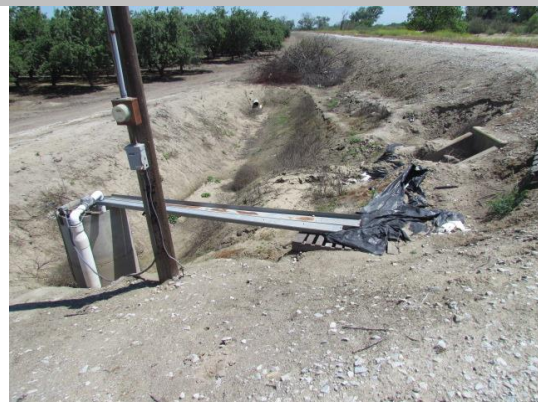
Photo 1 of 1 : SP_2019_NA0011_142_20_20190307_00010.jpg

LM Start	0.04	Rating **	U	Issue No.	20
LM End	0.04	Issue Type +	Ma	Location *	LS
Category	Earthen Levee			GPS Latitude/Longitude	
				Start	End
Item	Slope Stability			37.046624 °	37.046624 °
				-120.427317 °	-120.427317 °
DWR ID	DWR_NA0011_01_s_2014_20				
Comment Code					
S1 : Repair slope instability.					
Inspector Comment					
This is not a new erosion site, it should be repaired before the condition get any worse.

There is damage to the landside levee slope next to the concrete inlet structure.

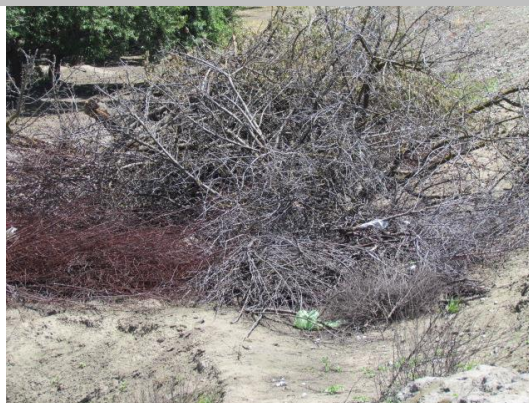
Photo 1 of 1 : SP_2019_NA0011_142_12_20190307_00003.jpg

Unwanted brush pile on the landside levee toe.

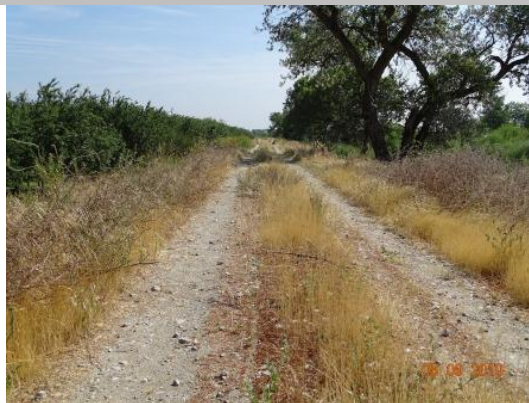
Photo 1 of 1 : SP_2019_NA0011_142_32_20190513_00034.jpg

View of vegetation along levee crown looking upstream. (Spring 2019)

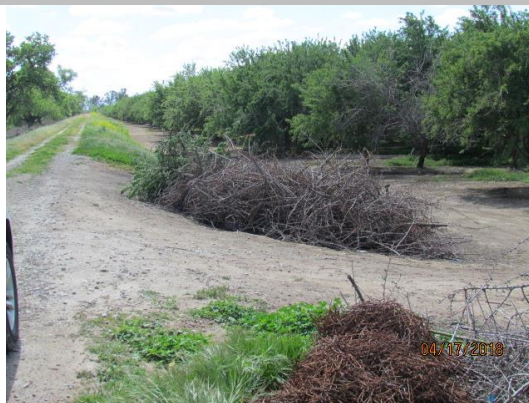
Photo 1 of 2 : SP_2019_NA0011_142_13_20190307_00004.jpg

Looking west at pruning pile on landward slope. (Spring 2018)

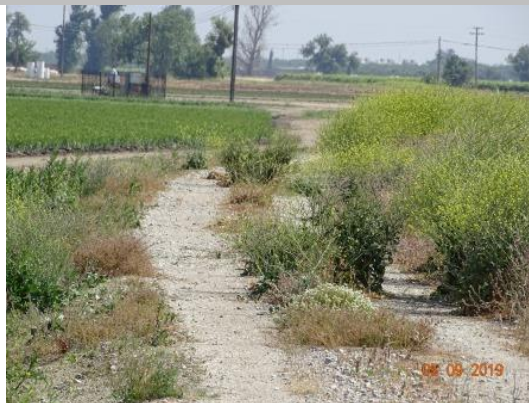
Photo 1 of 1 : SP_2019_NA0011_142_35_20190513_00037.jpg

View of vegetation along levee crown looking upstream. (Spring 2019)

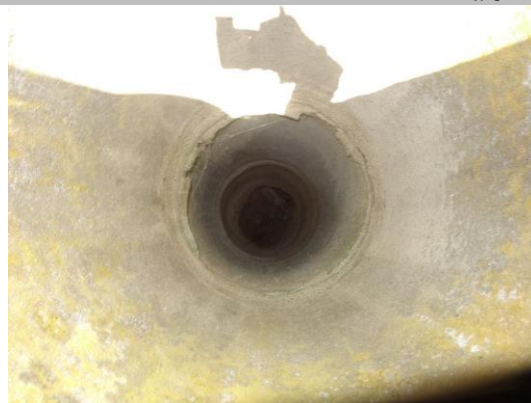
Photo 3 of 3 : UCIP_SP_2019_52847_71804.jpg

LM Start	2.10	Rating **	M	Issue No.	48 (cont)	
LM End	2.10	Issue Type +	En	Location *		
Category	Supplemental			GPS Latitude/Longitude		
				Start	End	
Item	DWR UCIP Field Study			37.065649 °	37.065649 °	
				-120.400663 °	-120.400663 °	
DWR ID	25042					
Comment Code						
Inspector Comment						
FS_ID:52847 DS_ID:25042 EP_NO: N/A Repair Type: Non-Urgent Crossing Status: Found UCIP Comments: 05/06/2014 Need to contact owner to determine if crossing goes through levee. (DWR UCIP - O. Magana) FIELD_STRUCT_DESC: 10-inch or 12-inch drainage discharge pipe of an unknown material through the levee, at an unknown depth. Crossing visible inside a concrete standpipe on the waterside (WS). Potential pump station on the landside (LS), approximately 100 feet from the standpipe. This crossing was field discovered. FS Date: 5/6/2014

Inside view of concrete standpipe.

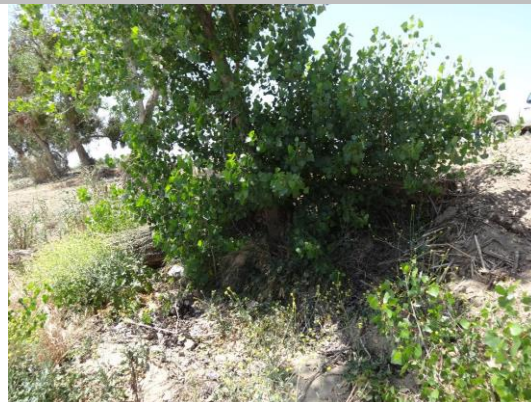
Photo 2 of 3 : UCIP_SP_2019_52848_69678.jpg

View of waterward slope--no signs of crossing visible.

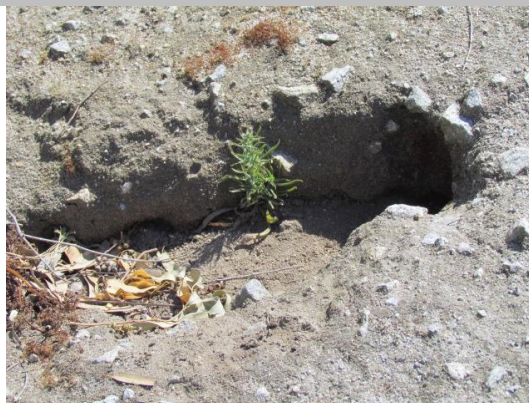
Photo 2 of 2 : SP_2019_NA0011_143_39_20190307_00031.jpg

Other rodent holes noted in the slope waterside levee section.

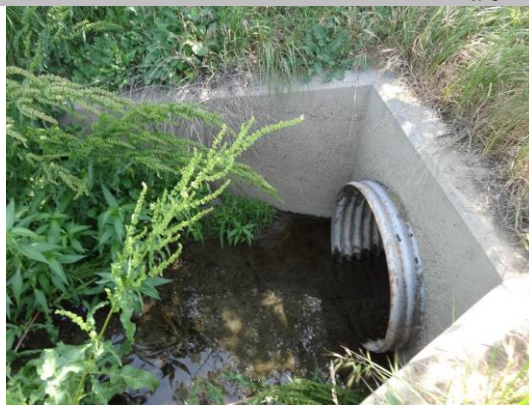
Photo 3 of 3 : UCIP_SP_2019_52830_71660.jpg

Pipe outlet on waterward side.

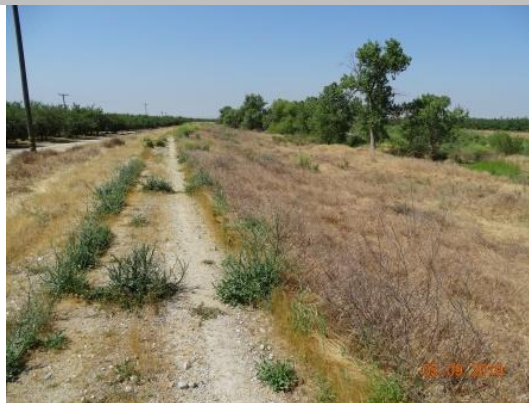
Photo 1 of 1 : SP_2019_NA0011_143_44_20190513_00051.jpg

View of waterside slope looking downstream. (Spring 2019)

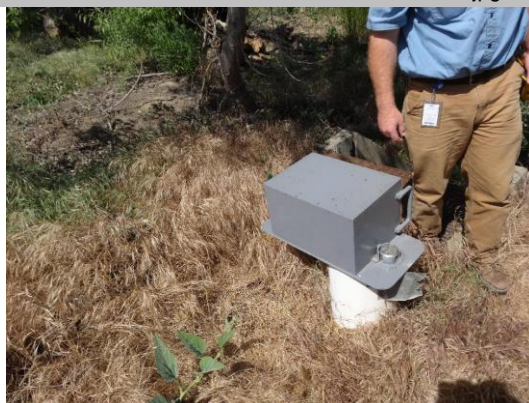
Photo 2 of 3 : UCIP_SP_2019_52834_64466.jpg

Locked box (unknown purpose) located on waterward side.

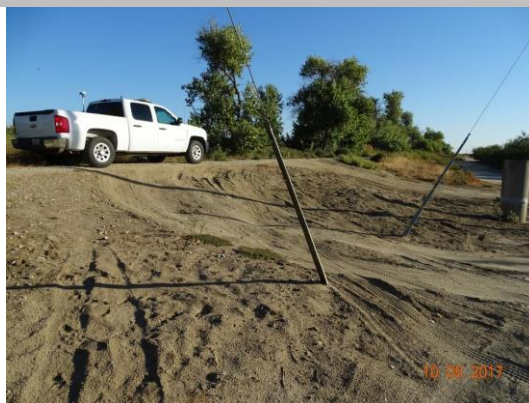
Photo 1 of 1 : SP_2019_NA0011_143_13_20190307_00010.jpg

Vehicle access to levee slope should be prevented and erosion repaired.

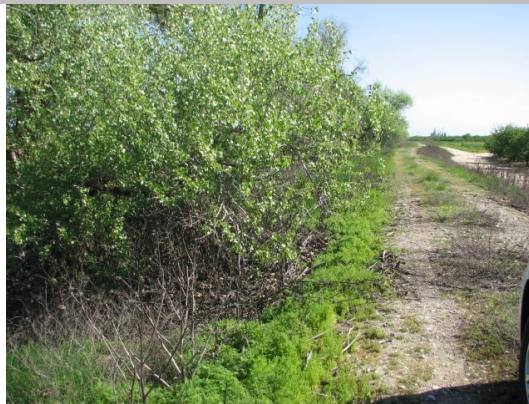
Photo 1 of 1 : SP_2019_NA0011_143_14_20190307_00011.jpg

Looking downstream at untrimmed tree on waterward shoulder and slope. (Spring 2018)

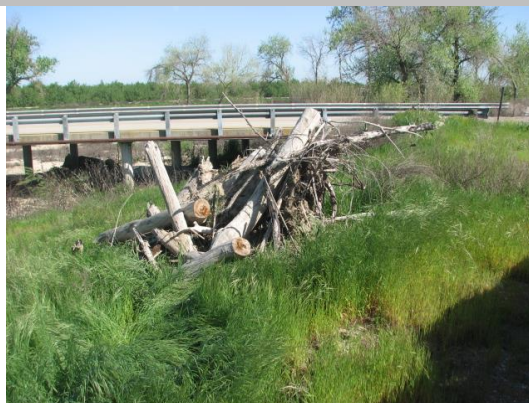
Photo 1 of 1 : SP_2019_NA0011_143_34_20190307_00027.jpg

Looking downstream at bush pile on waterward slope. (Spring 2018)

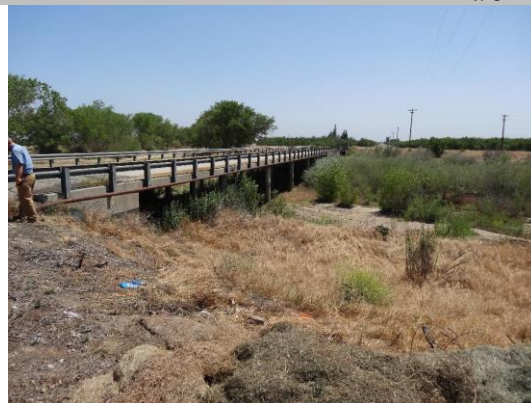
Photo 1 of 3 : UCIP_SP_2019_52839_71823.jpg

Conduit along face of bridge.

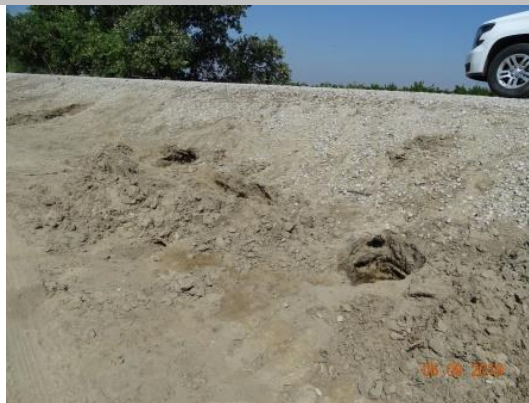
Photo 1 of 2 : SP_2019_NA0011_143_29_20190513_00055.jpg

Digging around valves recently occurred. Appears to be for maintenance of irrigation system. (Spring 2019)

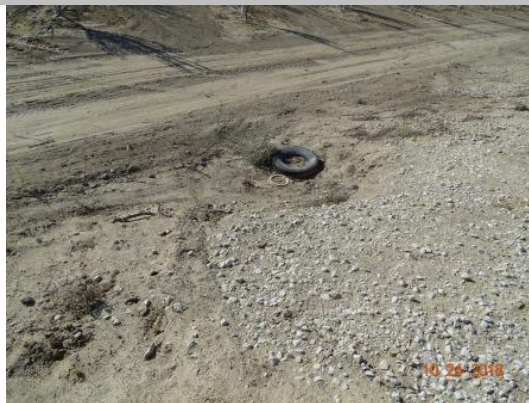
Photo 2 of 2 : SP_2019_NA0011_143_29_20190307_00023.jpg

Representative view of irrigation valve. (Fall 2018)

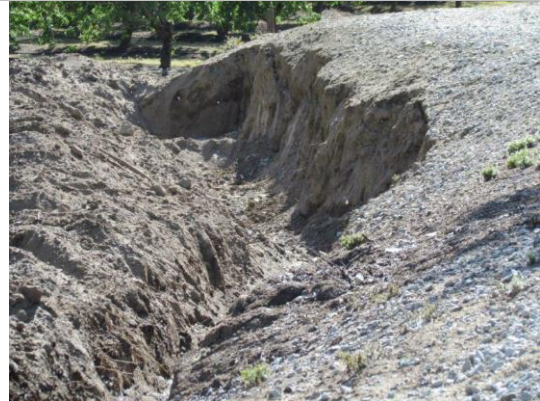
Photo 2 of 3 : UCIP_SP_2019_52842_75227.jpg

View of cut on LS slope of U2 at LM 1.49 (most downstream end of the open trench, photo 1 of 2).

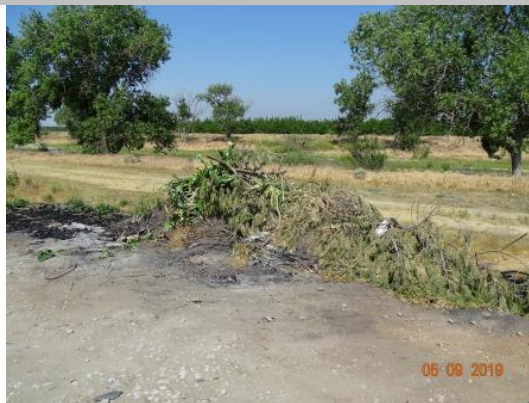
Photo 1 of 1 : SP_2019_NA0011_143_41_20190513_00057.jpg

Prunings for a burn pile left on waterside shoulder and slope of levee.
(Spring 2019)

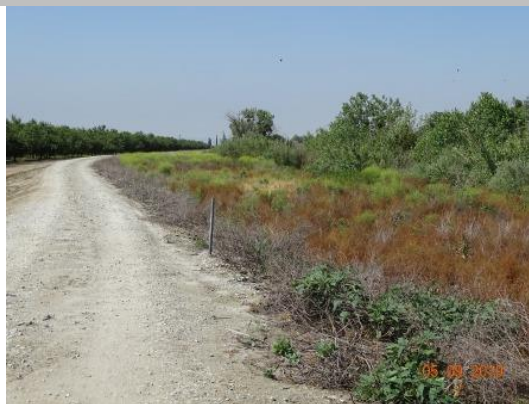
Photo 1 of 1 : SP_2019_NA0011_143_9_20190513_00058.jpg

View of vegetation on waterside slope looking downstream. (Spring 2019)

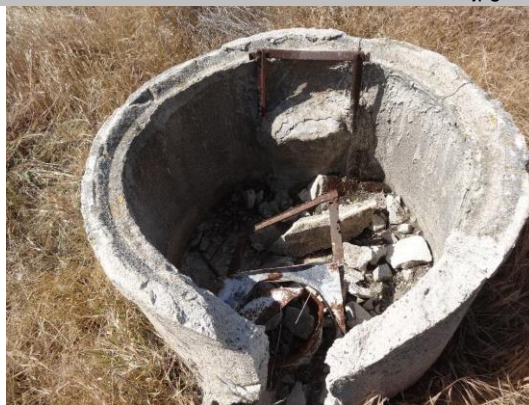
Photo 2 of 3 : UCIP_SP_2019_52844_71820.jpg

36-inch pipe full of concrete debris located on waterward side.

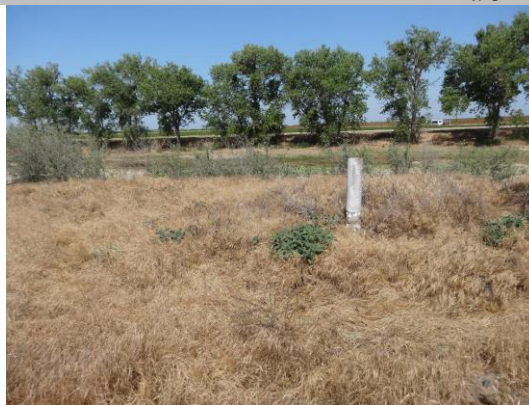
Photo 1 of 3 : UCIP_SP_2019_52845_71809.jpg

Tall concrete standpipe visible on waterward side.

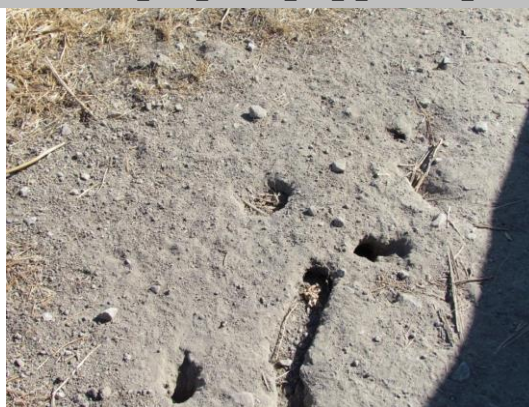
Photo 5 of 6 : SP_2019_NA0011_144_6_20190307_00009.jpg

More active rodent holes but no rodents observed at this specific location.

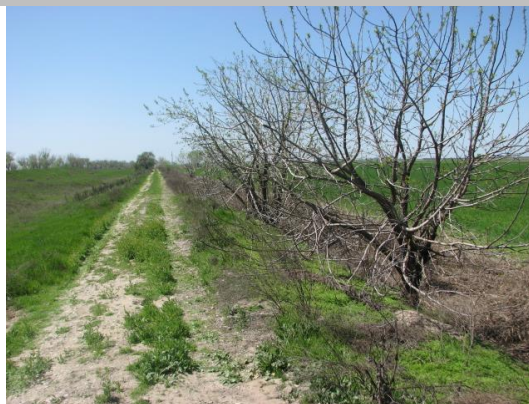
Photo 1 of 2 : SP_2019_NA0011_144_17_20190307_00018.jpg

Looking at cluster of walnut trees on landward slope. (Spring 2018)

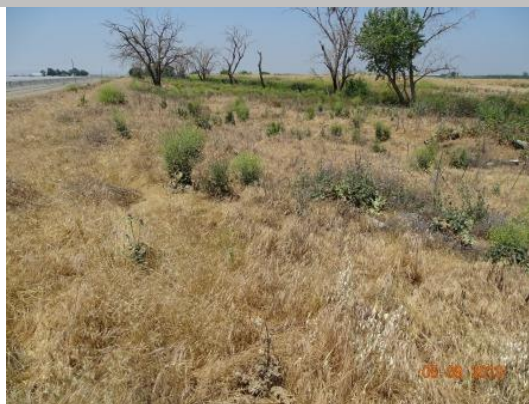
Photo 1 of 2 : SP_2019_NA0011_145_4_20190514_00031.jpg

View of waterside slope looking downstream. (Spring 2019)

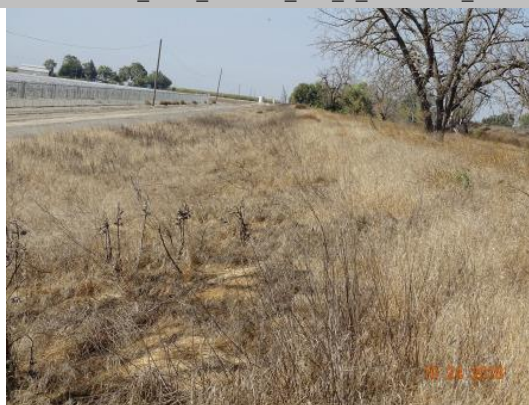
Photo 2 of 2 : SP_2019_NA0011_145_5_20190307_00003.jpg

View of wild growth on landside slope and shoulder. (Fall 2018)

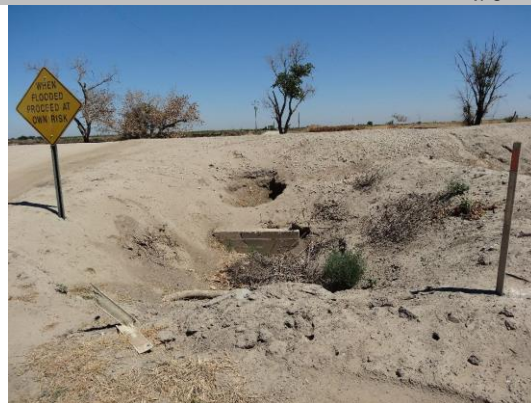
Photo 2 of 3 : UCIP_SP_2019_53154_75761.jpg

Sink hole and concrete headwall damage is visible on LS.

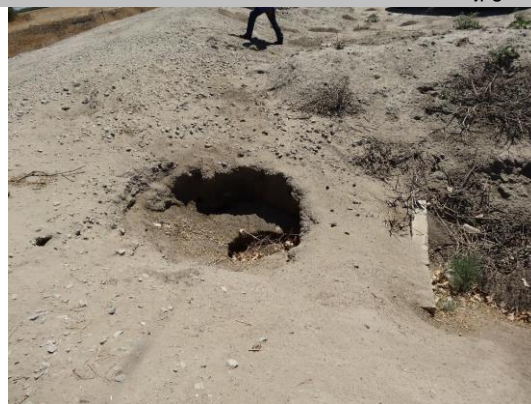
Photo 3 of 3 : UCIP_SP_2019_53154_75762.jpg

Sink hole located immediately above concrete headwall visible on LS.

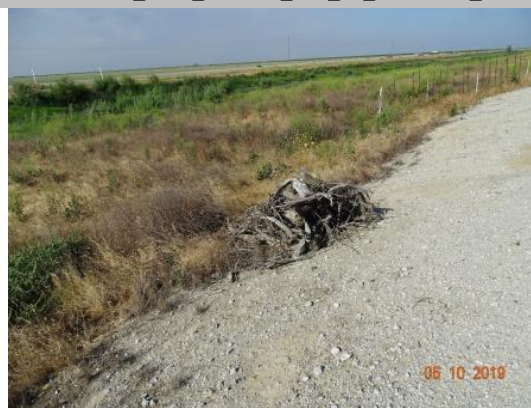
Photo 1 of 1 : SP_2019_NA0011_146_43_20190514_00036.jpg

Pruning pile left on the waterside shoulder. (Spring 2019)

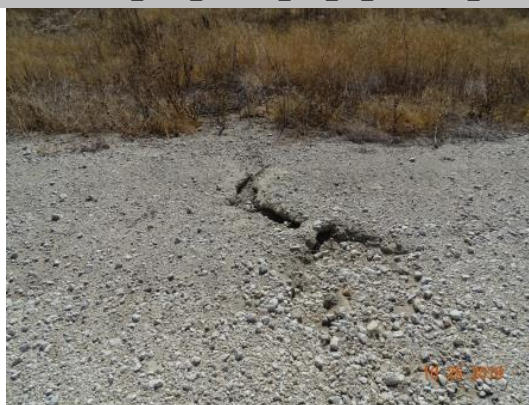
Photo 1 of 1 : SP_2019_NA0011_146_38_20190307_00022.jpg

Finger erosion on waterside slope. (Fall 2018)

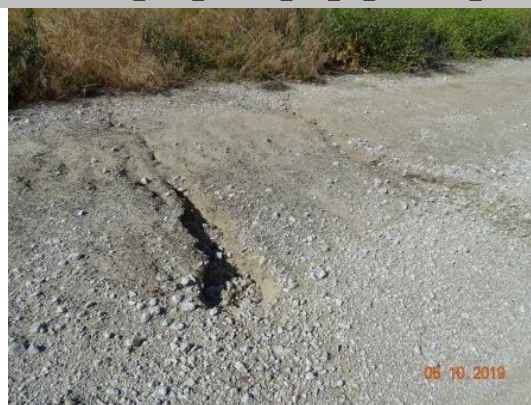
Photo 1 of 1 : SP_2019_NA0011_146_46_20190514_00038.jpg

Rills observed on waterside slope. (Spring 2019)

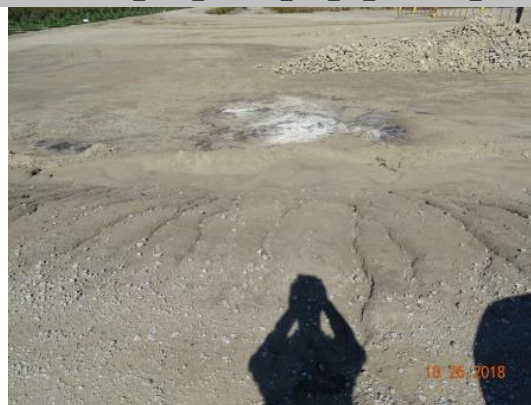
Photo 1 of 1 : SP_2019_NA0011_146_37_20190307_00021.jpg

Rill erosion on landside slope. (Fall 2018)

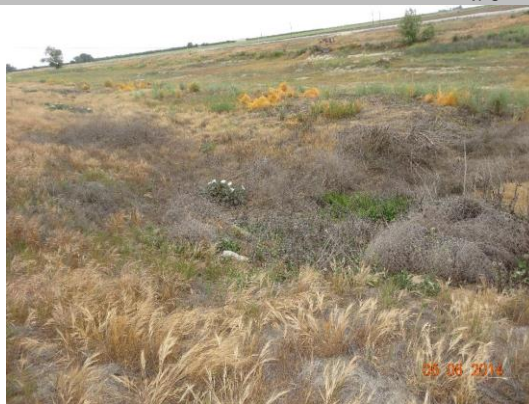
Photo 2 of 3 : UCIP_SP_2019_52859_69714.jpg

Concrete headwall covered by dense vegetation.

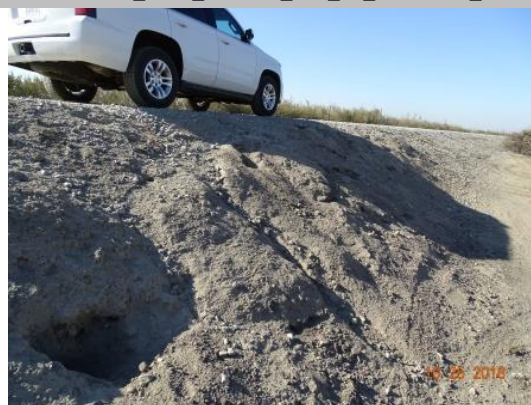
Photo 1 of 1 : SP_2019_NA0011_146_24_20190307_00012.jpg

Rodent activity on landside slope. (Fall 2018)

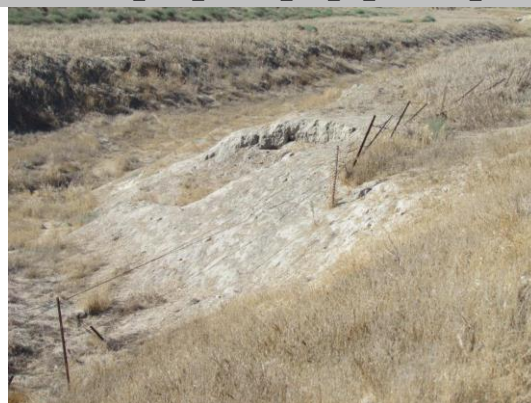
Photo 1 of 1 : SP_2019_NA0011_147_20_20190307_00008.jpg

Looking downstream at the old erosion site landside slope.

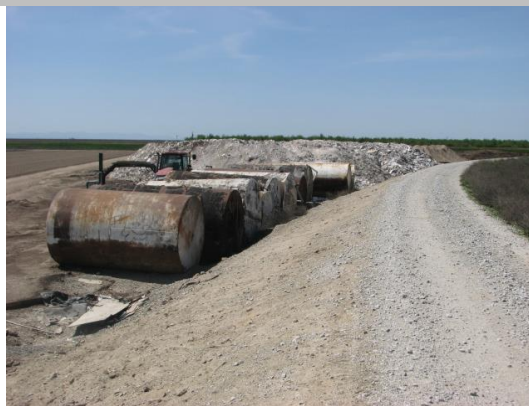
Photo 1 of 2 : SP_2019_NA0011_147_1_20190307_00001.jpg

Looking upstream at tanks and sheet rock piles at landward toe. (Spring 2018)

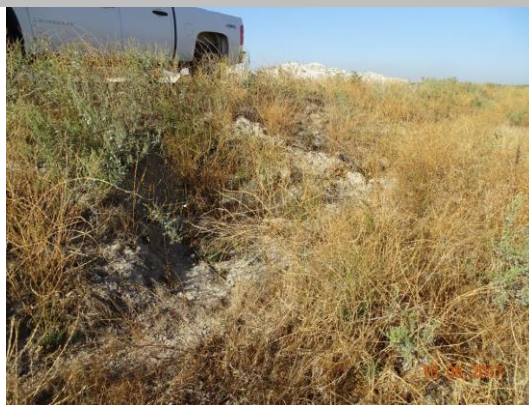
Photo 2 of 2 : SP_2019_NA0011_147_17_20190307_00007.jpg

Observed slump possibly exacerbated by rodent activity. 20' long x 8' high x 18" deep into levee slope.

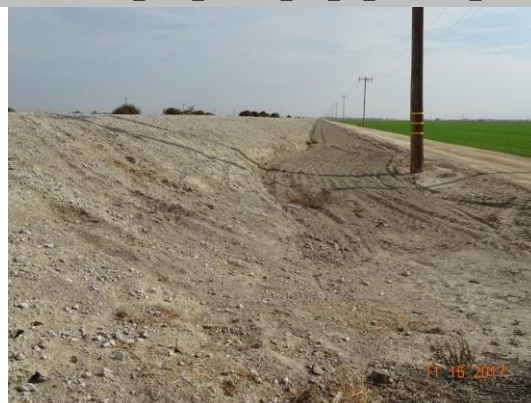
Photo 1 of 1 : SP_2019_NA0011_147_27_20190307_00013.jpg

Ag activity has cut into landside toe. Activity should be stopped and levee slope repaired.

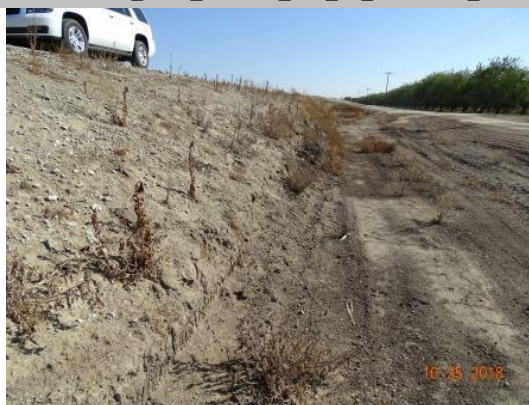
Photo 1 of 1 : SP_2019_NA0011_147_37_20190307_00020.jpg

agricultural equipment cutting into levee slope. (Fall 2018)

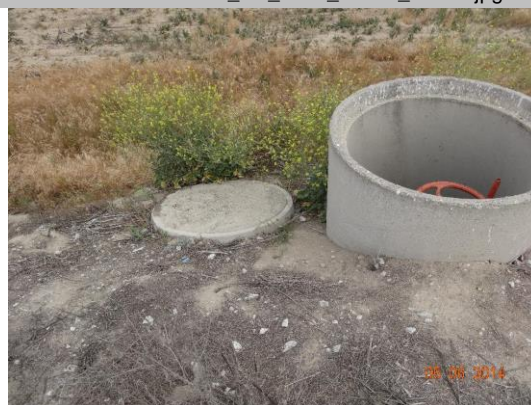
Photo 2 of 3 : UCIP_SP_2019_52860_64588.jpg

View of concrete standpipe and lid found on waterward shoulder.

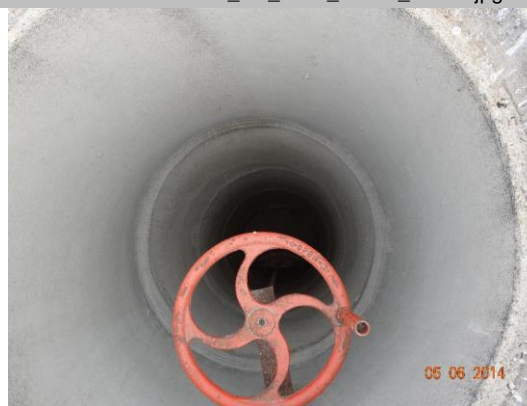
Photo 3 of 3 : UCIP_SP_2019_52860_64584.jpg

Inside view of standpipe located on waterward side.

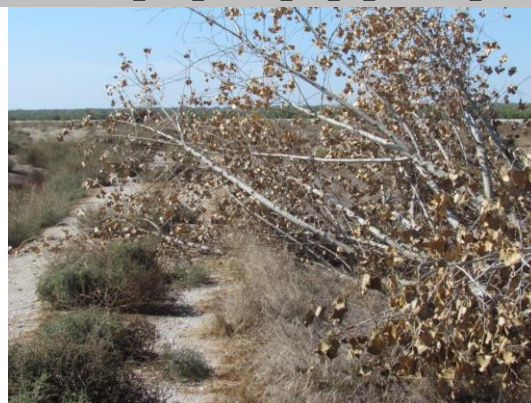
Photo 1 of 2 : SP_2019_NA0011_147_36_20190307_00018.jpg

Dead tree pushed upon the waterside slope and blocking the crown.

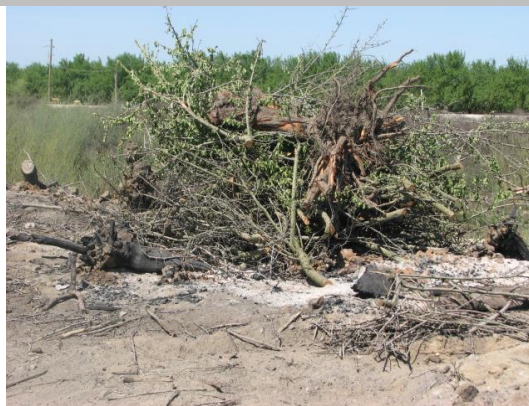
Photo 1 of 2 : SP_2019_NA0011_147_50_20190307_00024.jpg

Looking upstream at pruning pile on waterward shoulder and crown. (Spring 2018)

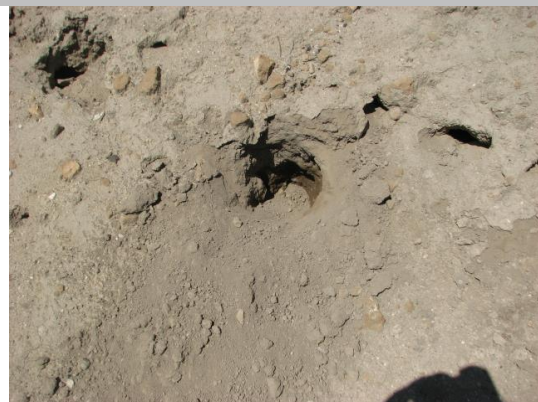
Photo 1 of 1 : SP_2019_NA0011_147_51_20190307_00026.jpg

Looking at typical rodent holes on landward slope. (Spring 2018)
